BUILDING SURVEY REPORT

**EXAMPLE Pimlico,
London, SW1V 4HF**

AS INSPECTED BY MODRICS CHARTERED SURVEYORS

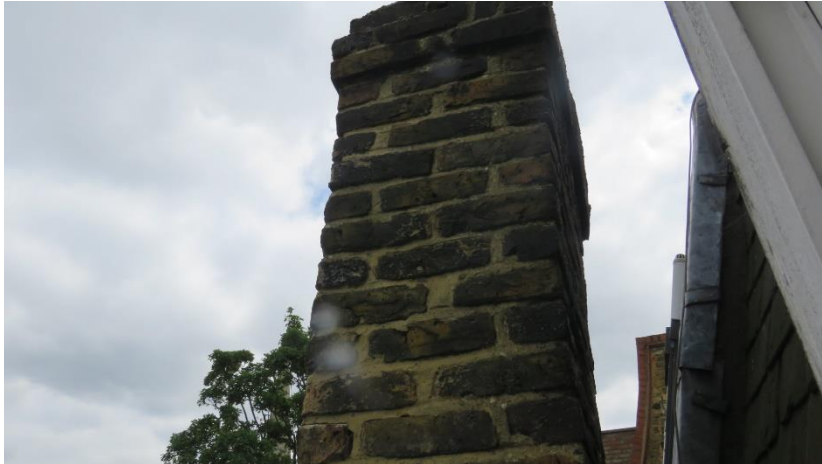
Evidence of leaning and cracking is noted to the rear left hand side chimney stack, we would recommend that further access for inspection and repair is undertaken and any strengthening works / stabilisation works undertaken to minimise the potential for further crack damage and or leaning. We consider these to be urgent to minimise the potential for further damage.

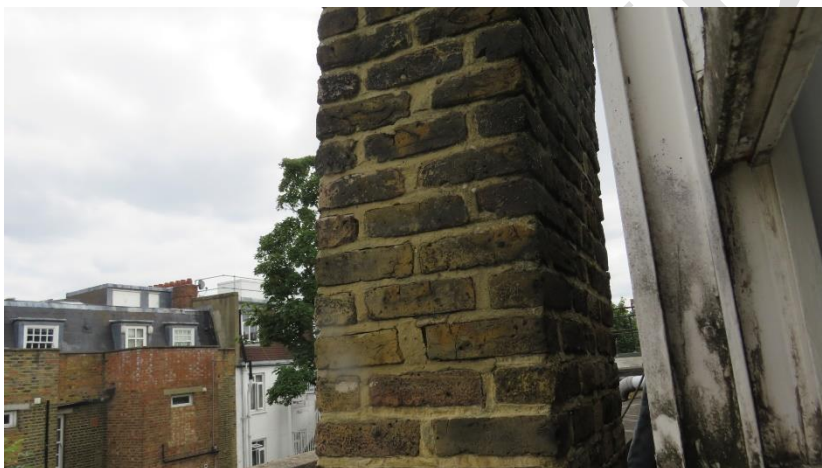
We note evidence of water ingress / high moisture meter readings internally immediately adjacent to the left hand side flank wall where the chimneys are positioned directly within the shower room area. This requires urgent investigation and repair.

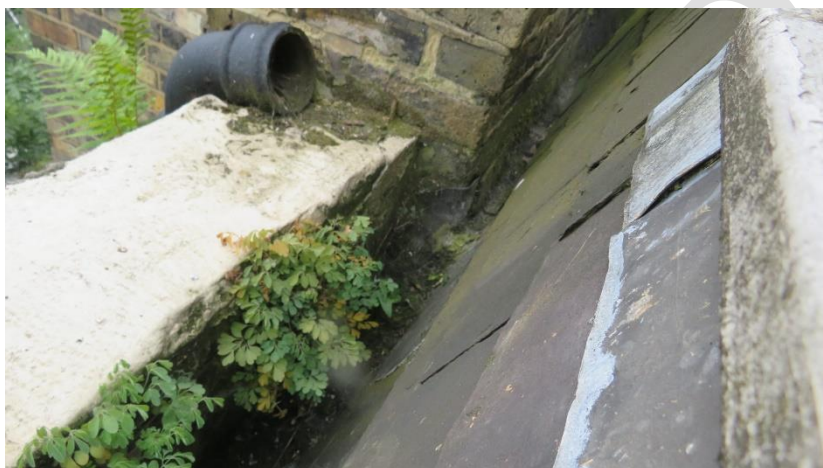
We note above the porch entrance there is a mineralised felt roof covering with large deposits of lichenous deposits on the surface. We note internally within the porch area there is high moisture meter readings for the full height and we are concerned that the roof may be leaking and requires further investigation and repair.

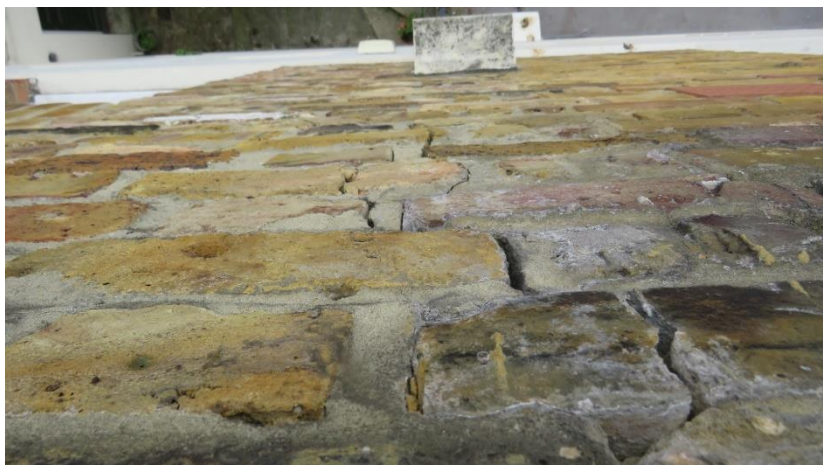
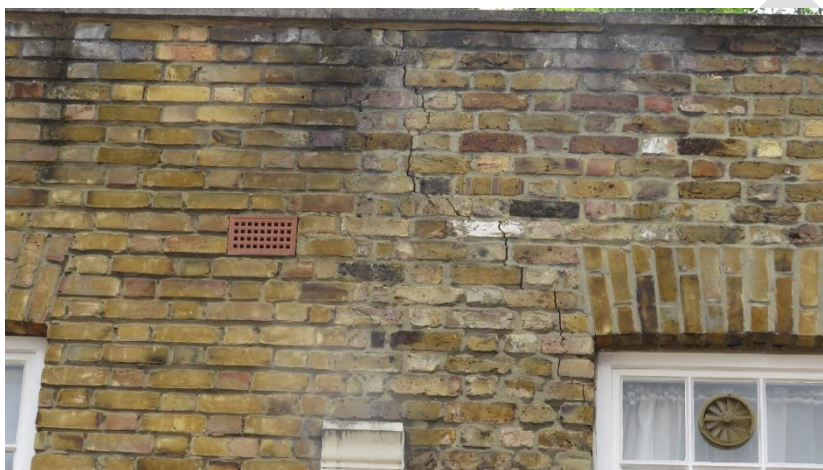
We note evidence of diagonal cracking extending through approximately 17 brick courses for the top left hand corner of the window serving the 2 / 3 storey side addition. This cracking continues through the brick parapets enclosure to the terrace serving the subject flat.

Internally there is no obvious signs of repetition of work, however these cracks will need urgent repair. We are concerned that this could give rise to damp or damage to the demise below which may also be exacerbated by the poor condition of the pedestrian covering / terrace area and it should be checked and confirmed as to whether there have been any complaints or disputes in relation to the same.

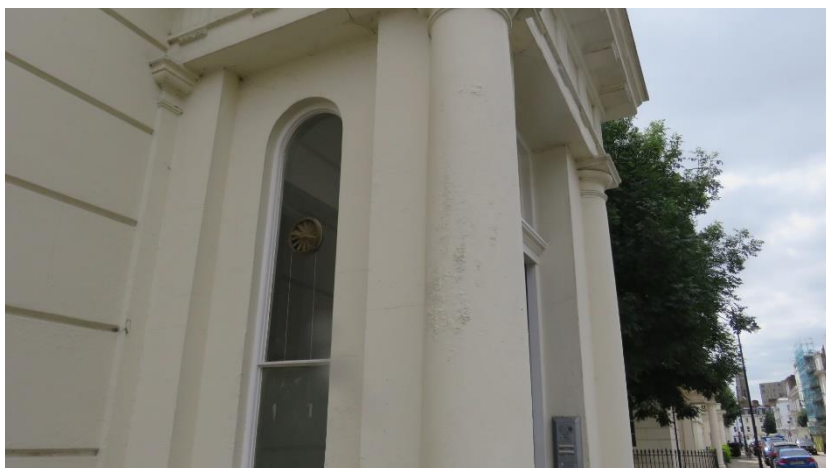
Evidence of water damage is noted to the rendered piers and the porch entrance area and also to the basement at low level, this will need further investigation and repair, see comments under drainage section of report in regards to possible flood damage particularly during heavy rain runoff.

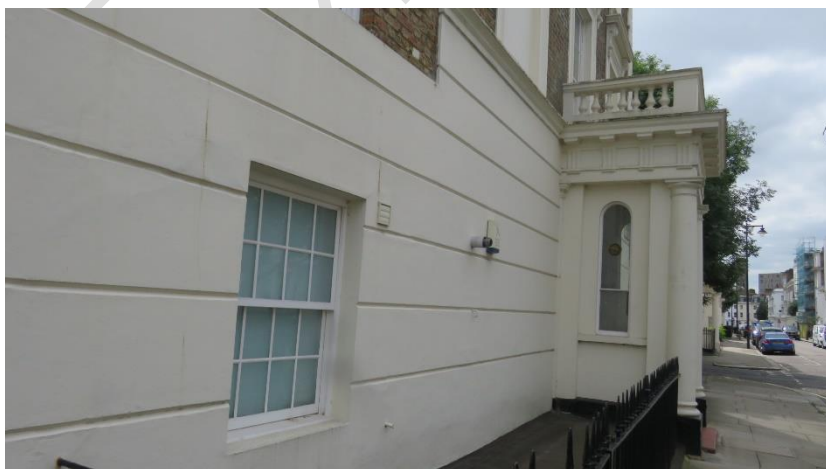
We note a slight bulging to the flank wall at mid height. Bulging in external walls in properties of this age and type, is occasionally encountered. Experience has shown that some solid walls were built without cross-bonding (that is internal walls not being built into the external walls), and broken sections of brickwork used to the face. External walls of this type have the appearance of comprising solid brickwork but, in fact, comprise two skins with a continuous lime mortar joint rising vertically in the centre. This construction was used to minimise costs by saving all facing bricks for outside and, in practice, may be found to have developed instability with age.

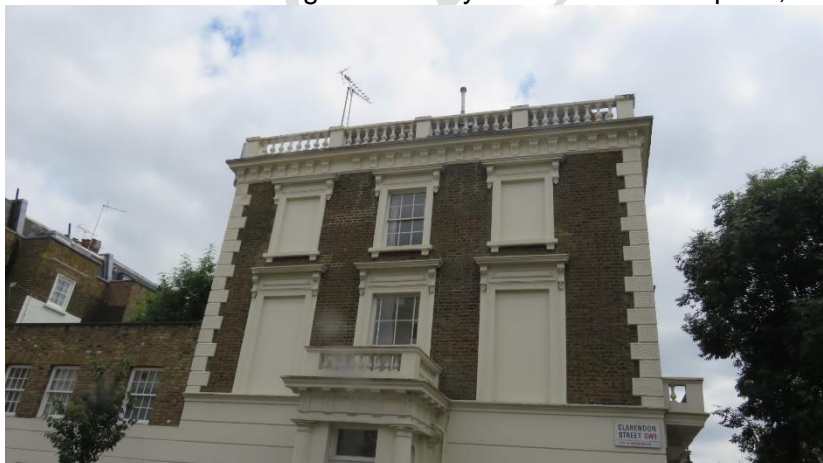
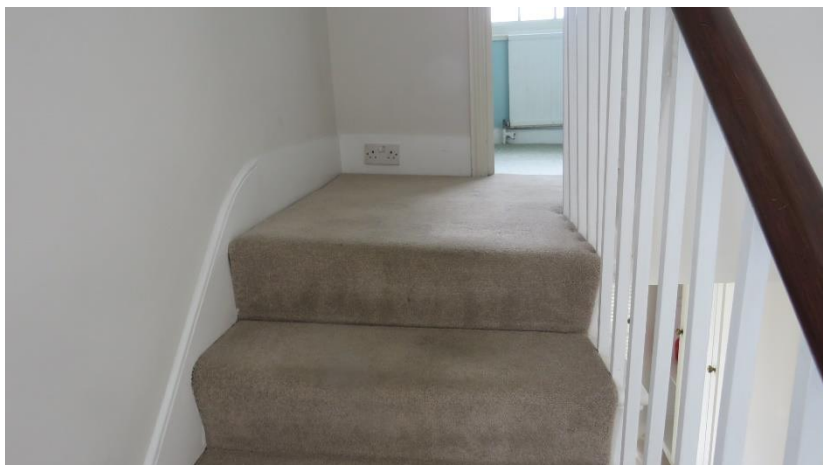
The original windows may have been removed and closed up for various reasons and this was not uncommon as window taxes were in place and to reduce liability owners infilled windows or perhaps as part of the later conversion into flats and infilling the window aperture to facilitate reconfiguring the internal alterations as part of the conversion works from a house to a self contained flats. The immediate complication of changing the left hand side window is this appears to conflict directly with the staircase and some consideration will need to be given to the opening and health and safety and privacy if a new window is to be installed. Landlord consent may also be required for any alterations to the property, see comments in relation to internal walls and changes to the layout within the reception, kitchen and bedroom one.

Opening the windows in principle appears feasible as the structural opening and support appears to be in place and, we note that the opposite property appears to have opened several windows on the flank, you may wish to check the planning register which is a public domain register to see what permissions were required / obtained.

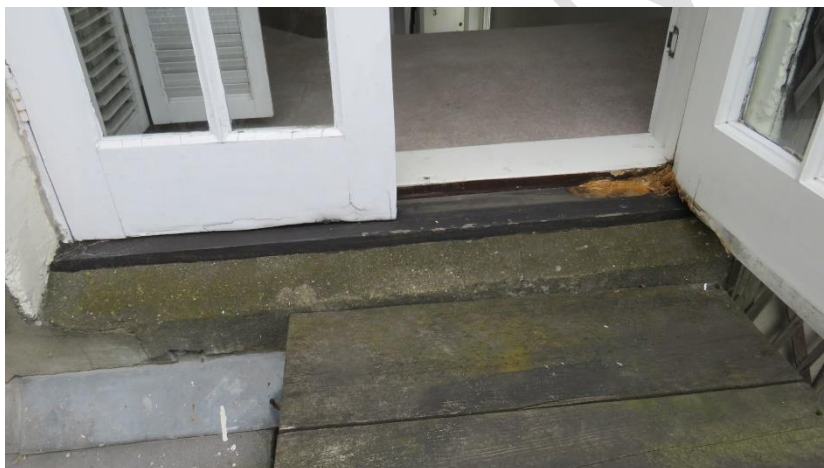
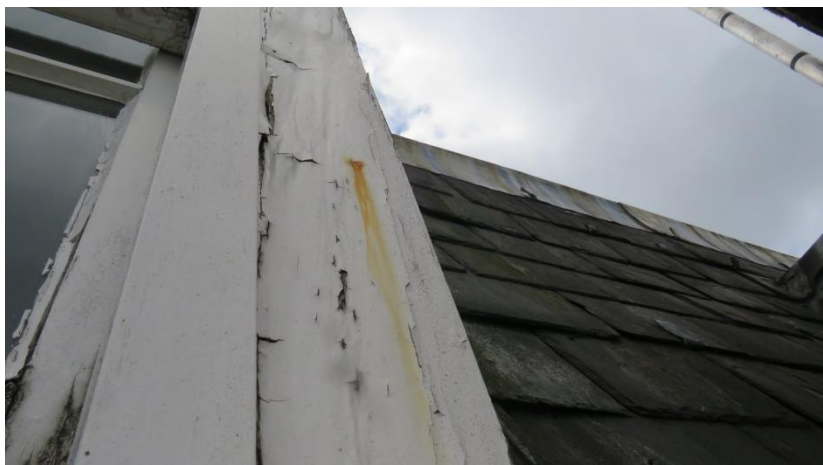
Timber painted windows and doors appeared to be in poor condition and require complete overhauling / and or partial replacement. We note evidence of rot and damage effecting the patio doors leading to the terraced. Evidence of rot to the windows to the left hand side serving bedroom three and also loss of texture generally to the windows.

Many of the windows are difficult to operate and badly fitting, and there is some deterioration both internally due to condensation, and externally due to failure to maintain the paintwork. A general overhaul is recommended to make the windows fully serviceable.

Prior to any repainting, any sections of decayed joinery should be cut out and replaced. It is possible that areas of rotted joinery have been painted over and therefore concealed.

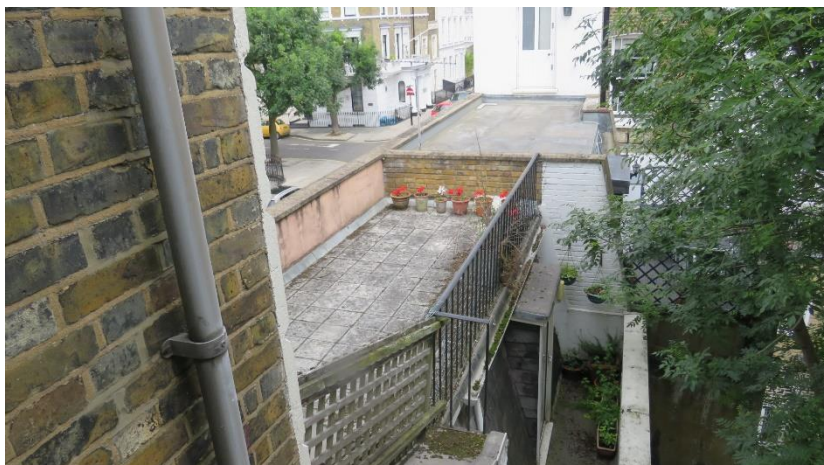
A brick parapet wall is featured to the front of the terrace and to the left hand side adjoining with the neighbouring terrace. To the rear there are metal painted railings with a timber trellis fixed to the building. We note that the brickwork to the front has suffered crack damage and we would refer to our comments under the main wall section of the report. This requires urgent repair.

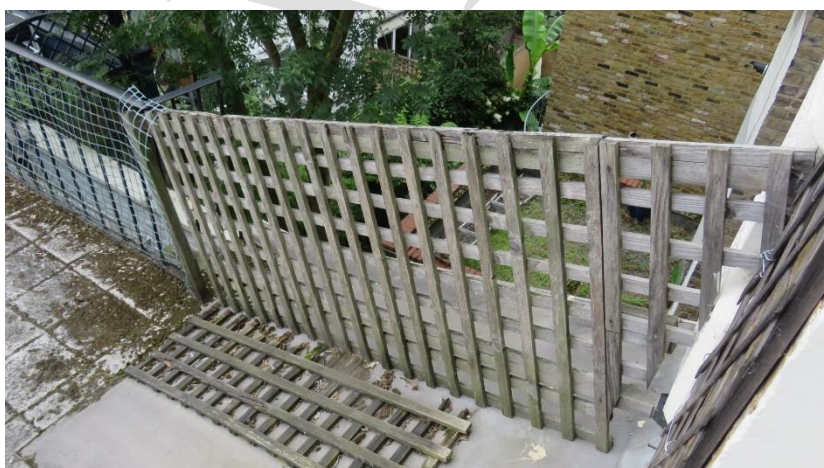
The railings to the rear are loose and potentially hazardous, the timber trellising is not fit for purpose and requires immediate upgrading. The edge protection at the rear of the terrace requires urgent repair to ensure it is fit for purpose and safe. Ideally balcony walling and hand rails should be a minimum 900mm from finished floor level as a matter of health and safety. Pedestrian tiles are laid on the terraced area, these are dated and showing signs of heavy wear and tear with lichenous deposits forming on the surface. This will need to be brushed off to minimise trip or similar related slip hazards. Lichenous deposits can also suffer frost damage and damage to the adjoining materials. It may be prudent to check with the flat owner below as to whether there are any ongoing disputes in relation to water ingress or damage. s to repair terraced areas can be disruptive, costly and difficult to do, particularly where third party ownerships are below.

Furthermore we would note that there is no real security provision between the 2 balconies with general access afforded from 1 property to another. Upgrading the security may be a consideration, again this may require planning permission for any changes the aesthetic appearance of the building and enquiries should be made in this regard.

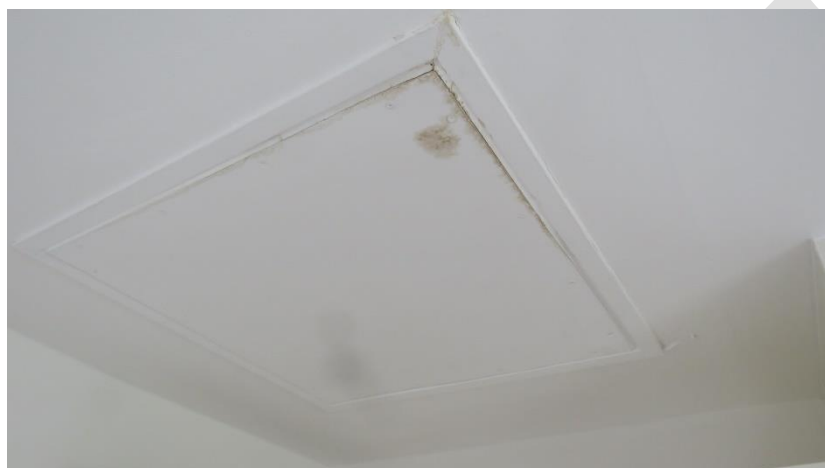
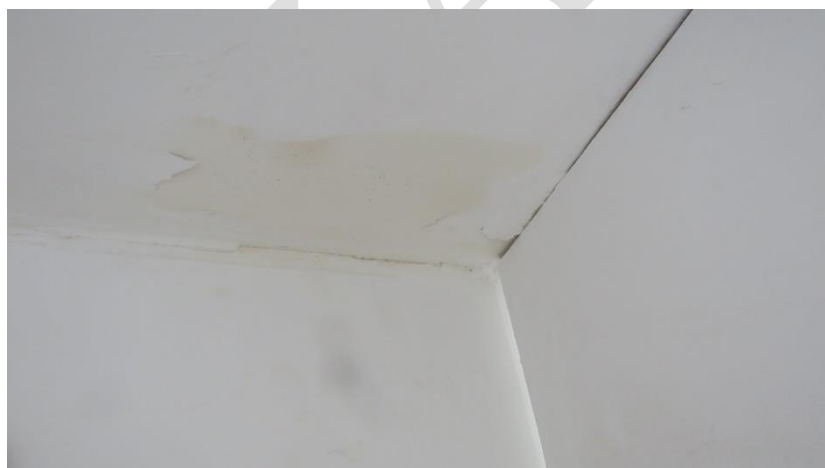
We note there is evidence of water staining to a number of the ceilings, in particular above the door within the reception room, we note the position of the boiler / plumbing installations above and this will need further investigation and repair. Water damage has affected the access hatch in the ceiling of bedroom three with similar water staining within the built in cupboard to

bedroom two effecting the ceiling and top section of the party wall. These areas of water damage will need urgent investigation and repair. Peeling and deterioration is noted to the paint finish within the shower, this is possibly due to high humidity levels which can generate mould and condensation related problems. The control of condensation is a careful balance between heating and ventilating the property, these areas will need to be washed off with a detergent and surfaces stabilised prior to redecoration.

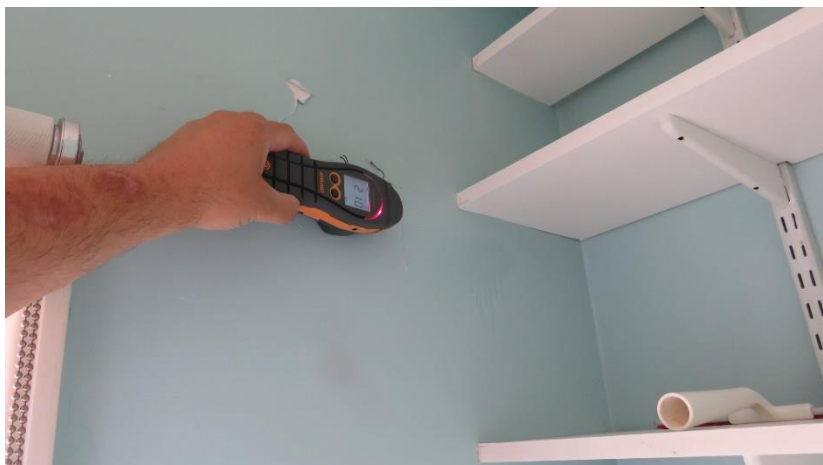
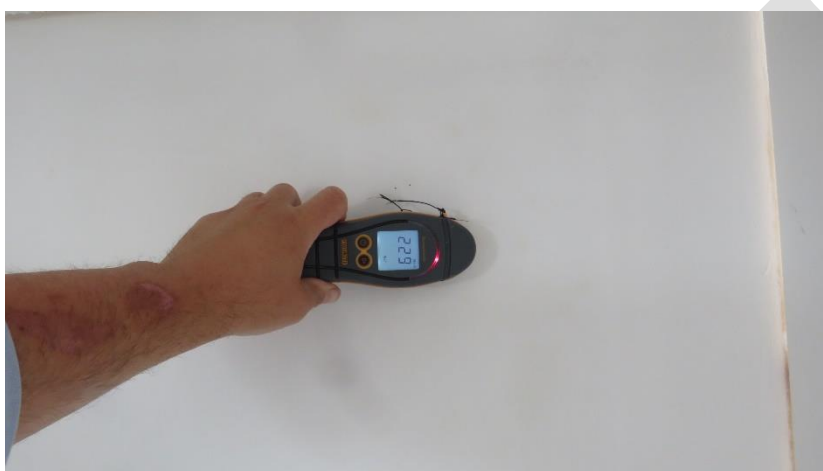
Using a hand held moisture meter some high meter readings were noted within bedroom two to the party wall within the built in cupboard. Also within bedroom one to the front left hand corner around the window at mid height. High readings were also noted within the shower room and behind the WC and also below the window in the second floor hallway area with high moisture meter readings also noted within the ground floor entrance area. These areas of dampness will need investigation and repair to minimise the potential for further damage.

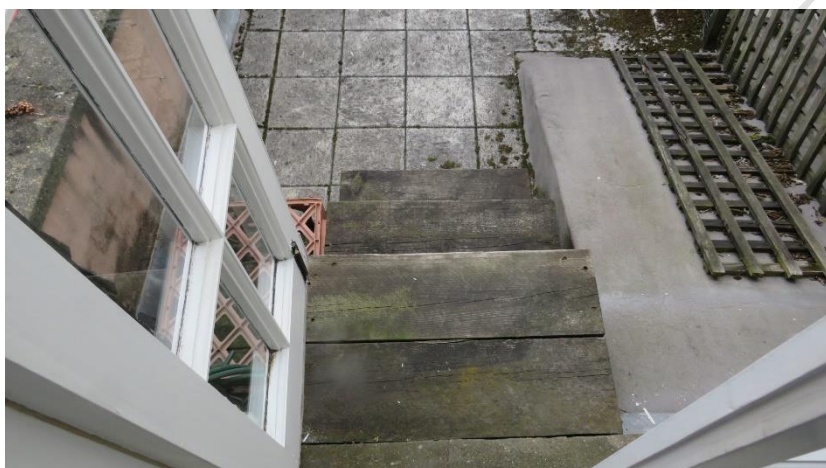
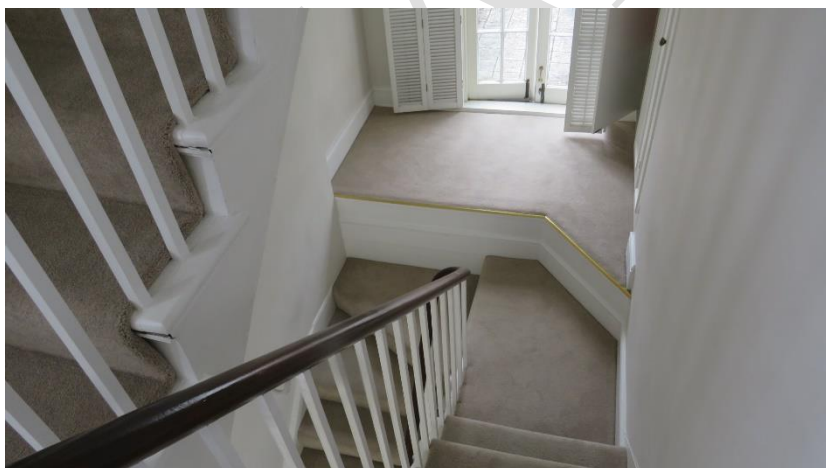
Emergency lighting and smoke detection is located in the common parts, the common part areas are showing signs of heavy wear and tear, the carpets are in poor condition and the internal common parts require redecoration. See legal section of report, you should check through your solicitor as to whether an asbestos management plan has yet to be prepared for the common parts. Such plans are mandatory with effect from May 2004.
