BUILDING SURVEY REPORT

**Example Report
Ealing
W13**

AS INSPECTED BY MODRICS (SURVEYORS) LIMITED

On: 7th June 2021

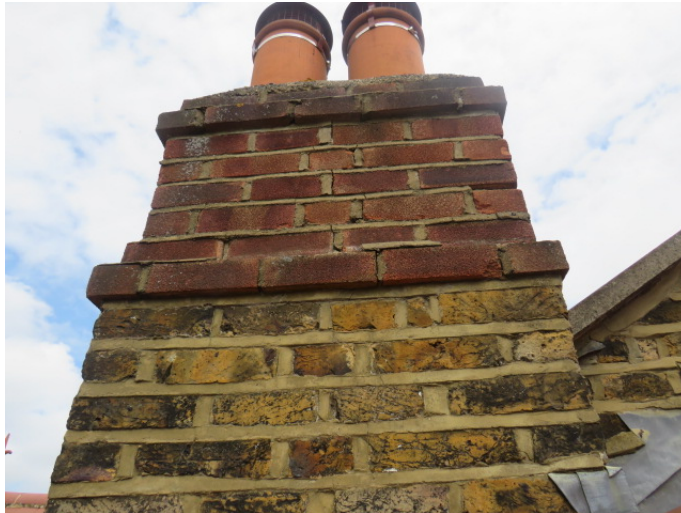
Slight leaning is evident to the chimney stacks, but otherwise no obvious signs of any significant cracking where possible to view. We note some minor hairline cracking to the pointing which will need repair.

order to prevent such dampness occurring. In this regard, some local deterioration and weathering is noted to the surface brickwork and pointing and this requires repair. When any pointing is carried out it is essential that the joints are raked out sufficiently, usually to a depth not less than 12mm so that the new pointing is given sufficient key. Failure to do this can result in the new pointing simply cracking and falling out over a relatively short timescale. The pointing itself should not be stronger than the bricks to which it is applied. Too high a cement content can allow shrinkage cracking.

(A number of spalled bricks have been patched with mortar. This is a temporary repair and proper cutting out and replacement, with new bricks, will be required in due course).

In order to slow down future deterioration of the brickwork, it is recommended that the brick surfaces be treated with a microporous transparent water-proofing solution. These solutions have the ability to prevent rain penetration while at the same time allowing trapped moisture to dry out. They are not long lasting and will require re-treatment in conjunction with future external redecoration programmes.

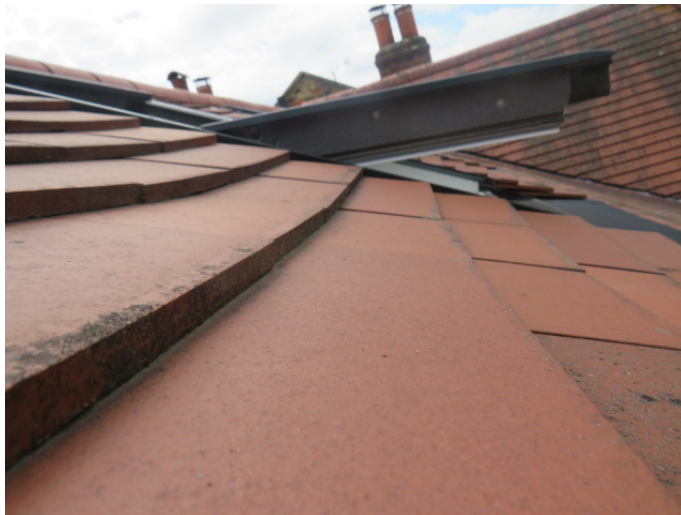
We noted some evidence of lichenous deposits to the surface of the roof tiles and, ideally, these should be brushed off as these can cause deterioration of roof coverings and if they become dislodged in gutters they can cause blockages and damp penetration problems to the structure beneath.

We note some slight deterioration evident to the mortar pointing to the hip tiles which will need local repair.

The general condition of the roof tiles were found to be in serviceable condition, despite the effects of weathering. It is important to maintain the condition of these tiles, not only to secure them but to render these parts of the roof weathertight.

In summary the roof is approaching an age where regular maintenance will be necessary together with the eventual replacement. Overhauling of the roof can be undertaken in the short term and this will include replacing any cracked, soft or slipped tiles and a general check made around the detailing of the chimney stacks and ridges to ensure the structure remains generally weathertight.

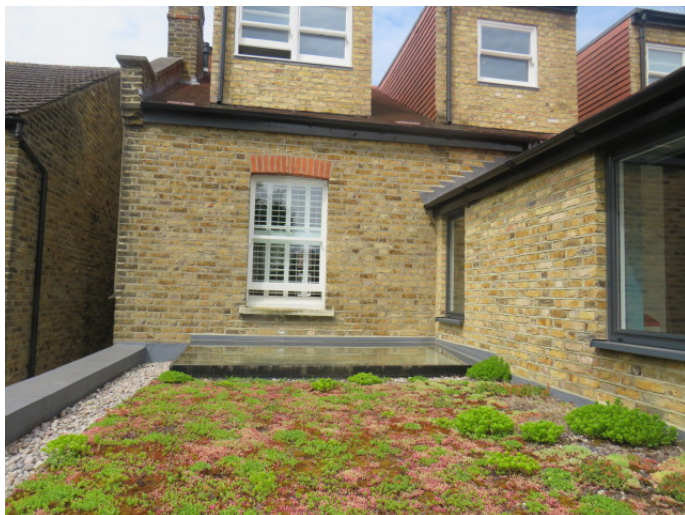
The rainwater goods are formed in a mixture of modern plastic and cast iron sections. Generally the gutters and rainwater goods were found to be free from obvious signs of leakages however we note some staining, possible leakage, to the uPVC soil stack to the rear left hand side. This will need investigation and repair.

The older cast iron sections are revealing indications of corrosion, particularly to their rear surfaces where the application of paintwork has been thinnest. All cast iron rainwater goods should be overhauled, including the removal of rust, and sections primed and painted.

The remaining cast iron rainwater sections should be replaced as soon as practicable in modern plastic material.

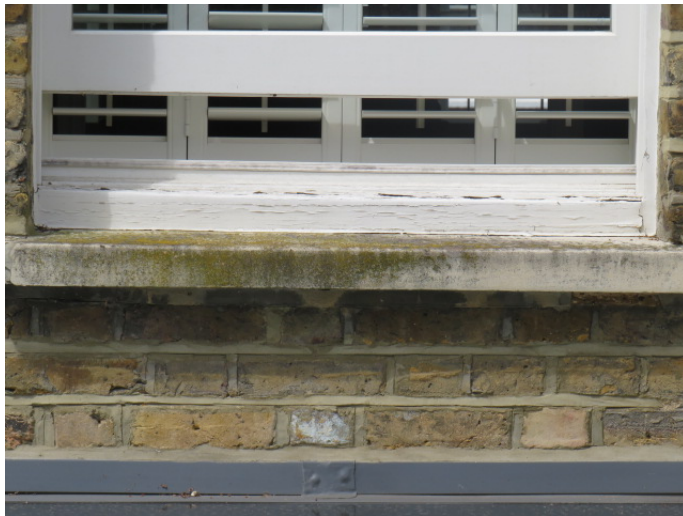
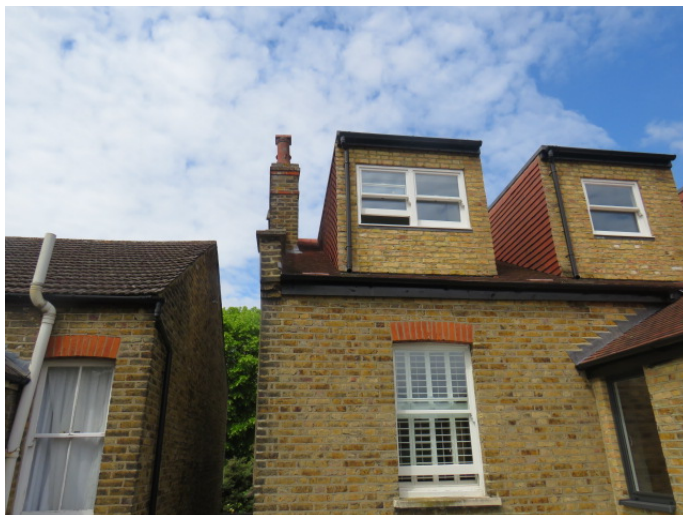
We note some loss of texture to the timberwork/detailing to the first floor front elevation, with some loss of texture noted to the previously painted timber window sub-frames to the front bay windows and also to Bedroom 2 to the rear.

Prior to any repainting, any sections of decayed joinery should be cut out and replaced. It is possible that areas of rotted joinery have been painted over and therefore concealed.

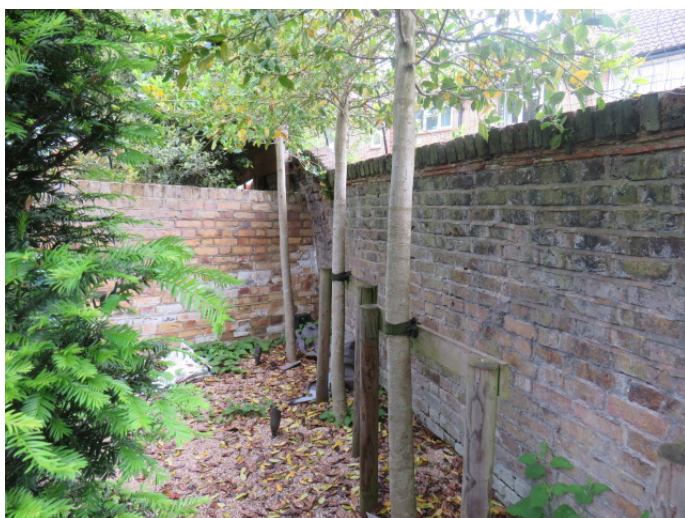
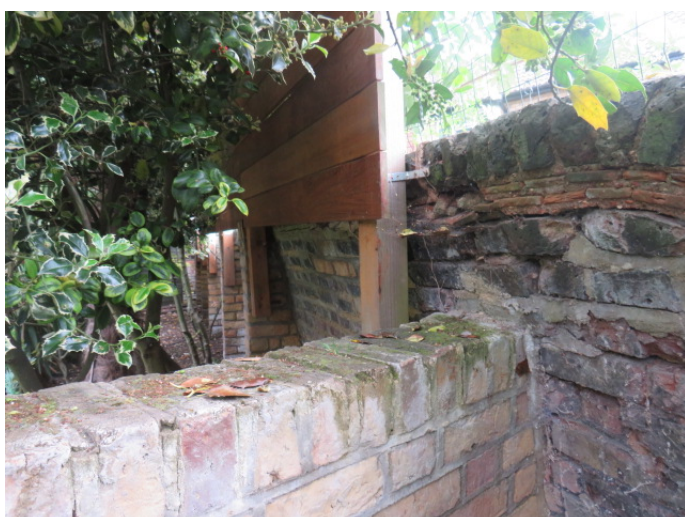
Brick walls are featured to the rear. These are largely obscured/covered with established vegetation. We note the rear boundary has suffered movement and is partly laterally supported by the boundary wall with a number of brick buttresses installed to the boundary wall within No.6 North Avenue.

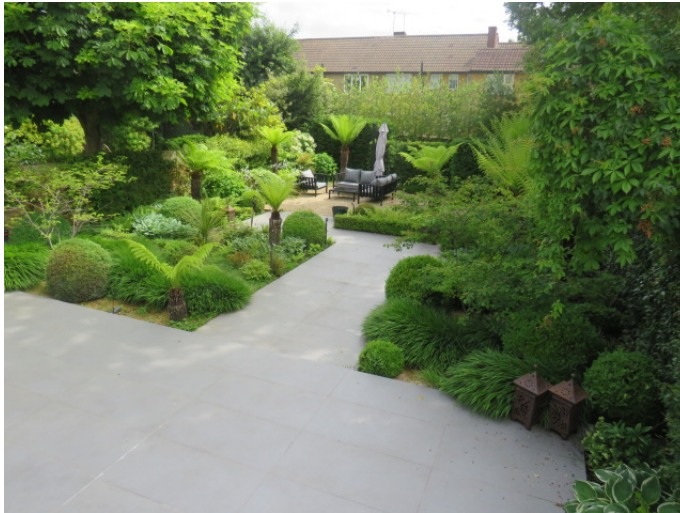
The gardens are in a seasonal condition, and there are some cracked, weathered and uneven paved areas.
