# HOME BUYERS REPORT

## **Example Report Ealing, London, W13**

AS INSPECTED BY MODRICS (SURVEYORS) LIMITED

On: 21st February 2021

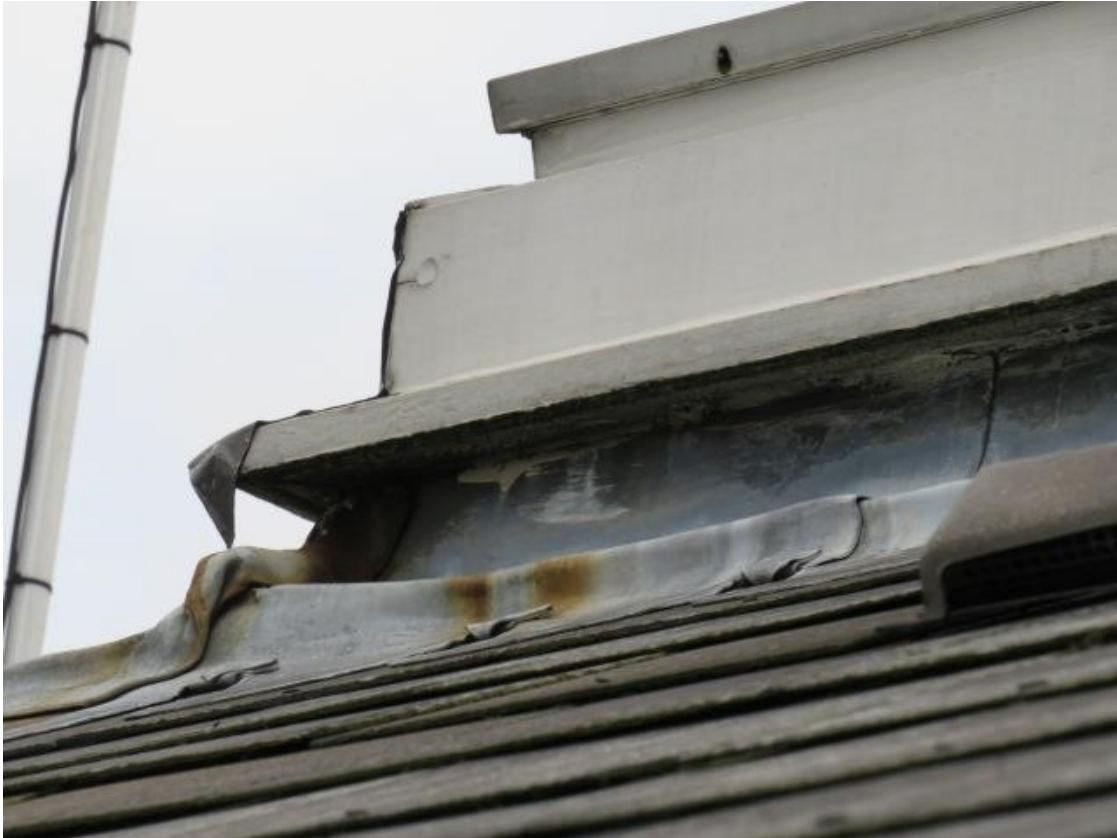
We noted some evidence of lichenous deposits to the surface of the roof slates and, ideally, these should be brushed off as these can cause deterioration of roof coverings and if they become dislodged in gutters they can cause blockages and damp penetration problems to the structure beneath.

The general condition of the roof slates were found to be in serviceable condition, despite the effects of weathering. It is important to maintain the condition of these tiles, not only to secure them but to render these parts of the roof weather-tight.

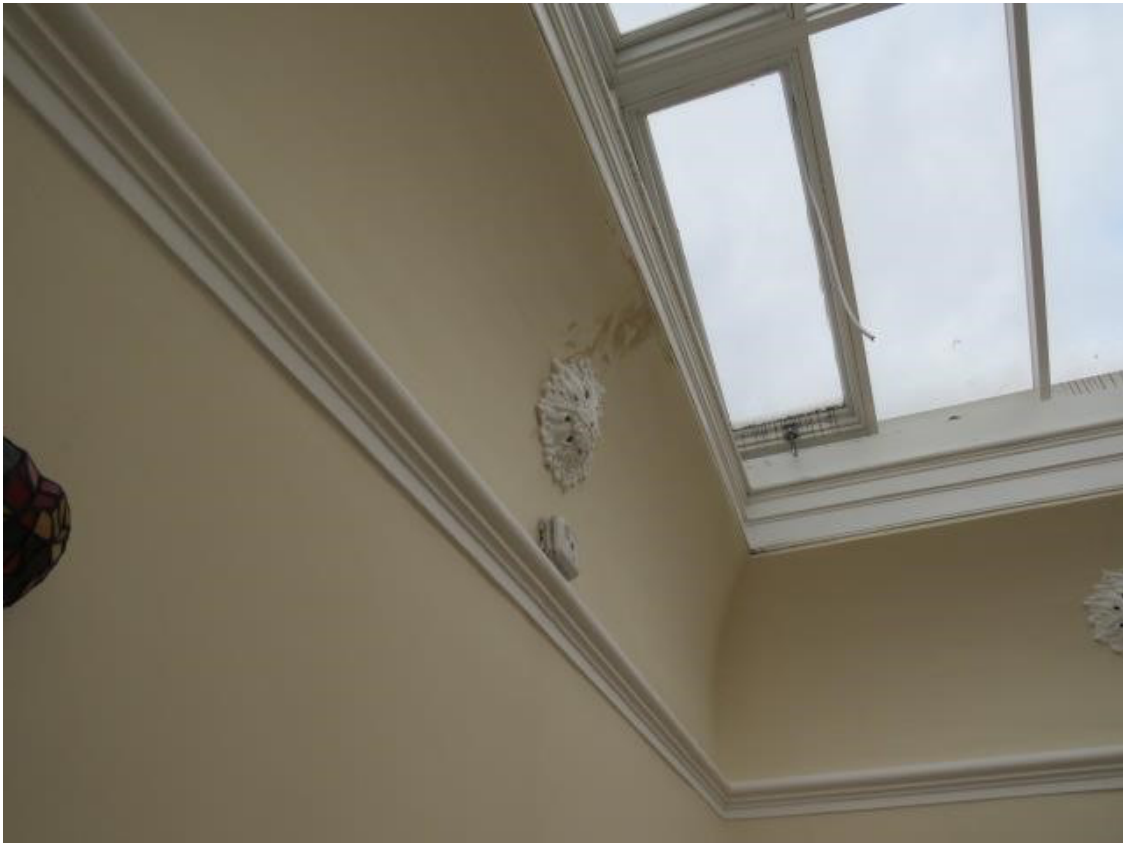
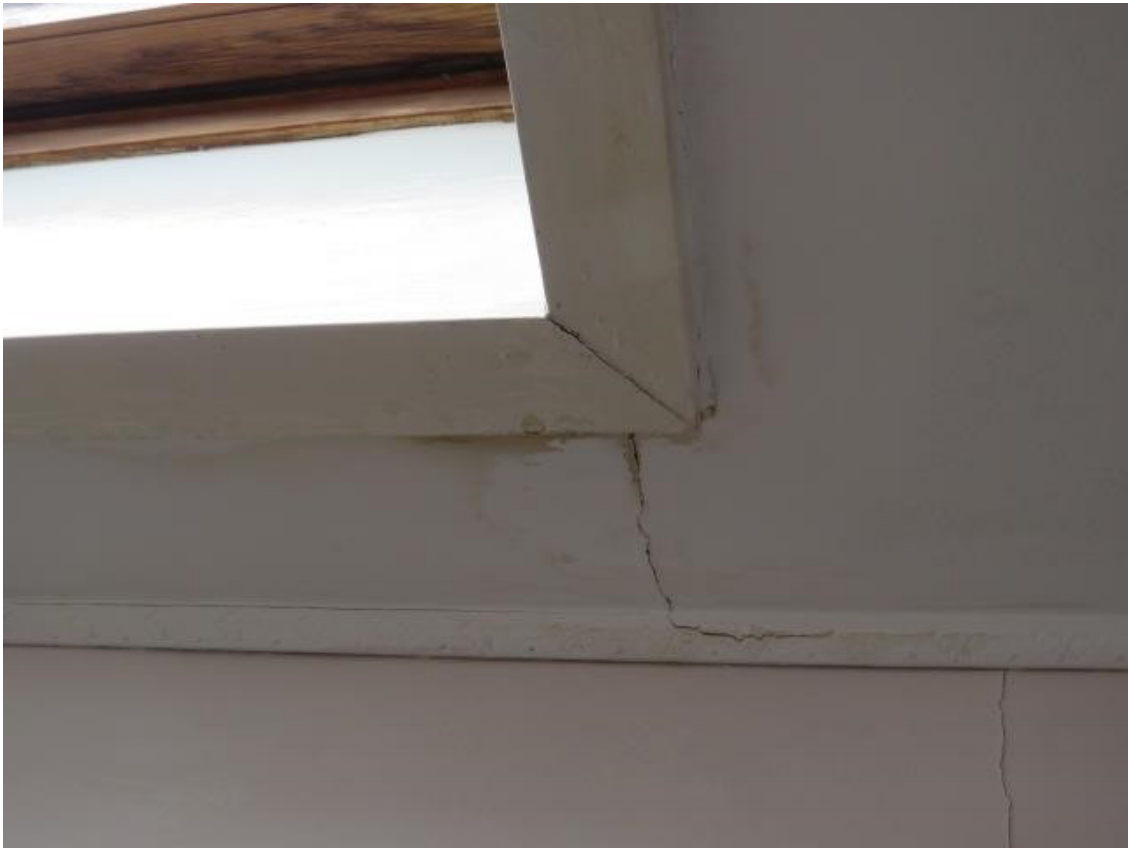
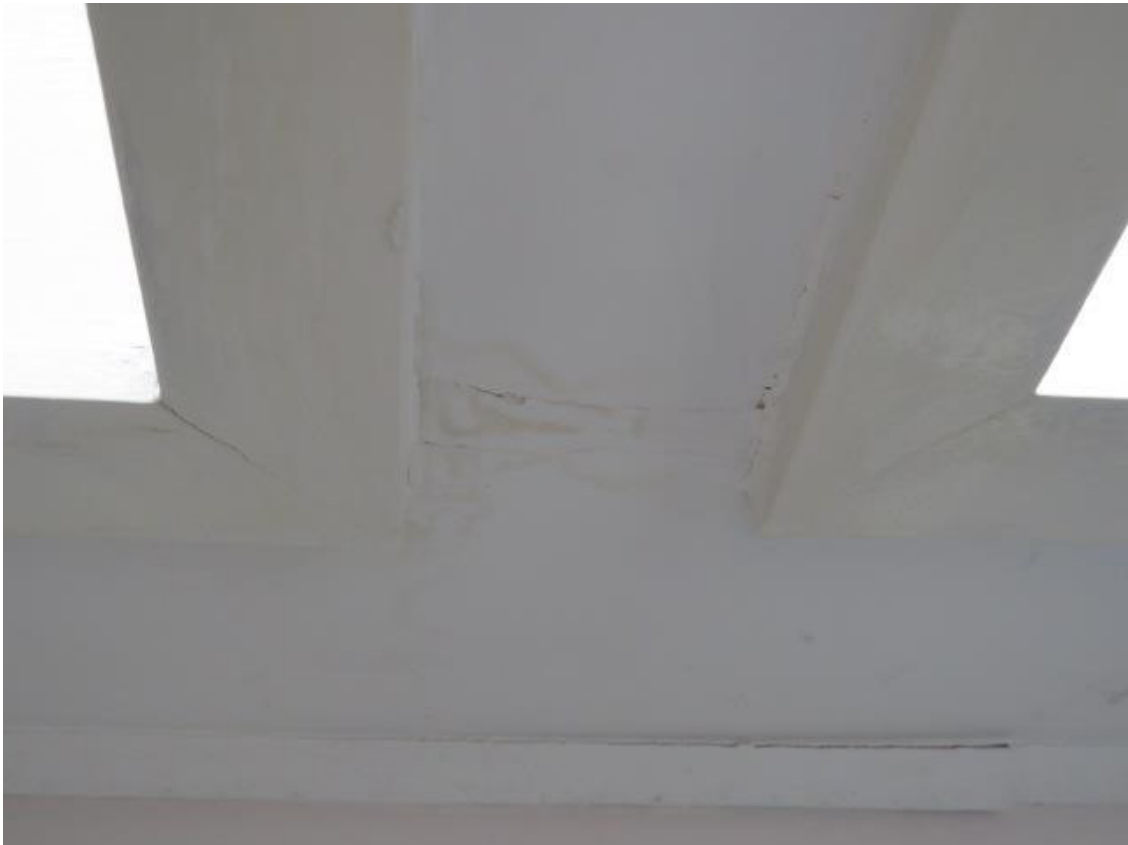
We note evidence of water damage around the central sky light area at various locations with similar water staining and damage evident around the roof windows within the reception room, these areas of water ingress will need further investigation and urgent repair. From our limited inspection of the roof the flashings appear to be heavily stained, possibly allowing moisture to penetrate through causing leakages around the glazed atrium.

When repairing the roof the contractor will need to be careful to avoid damaging adjoining slates.

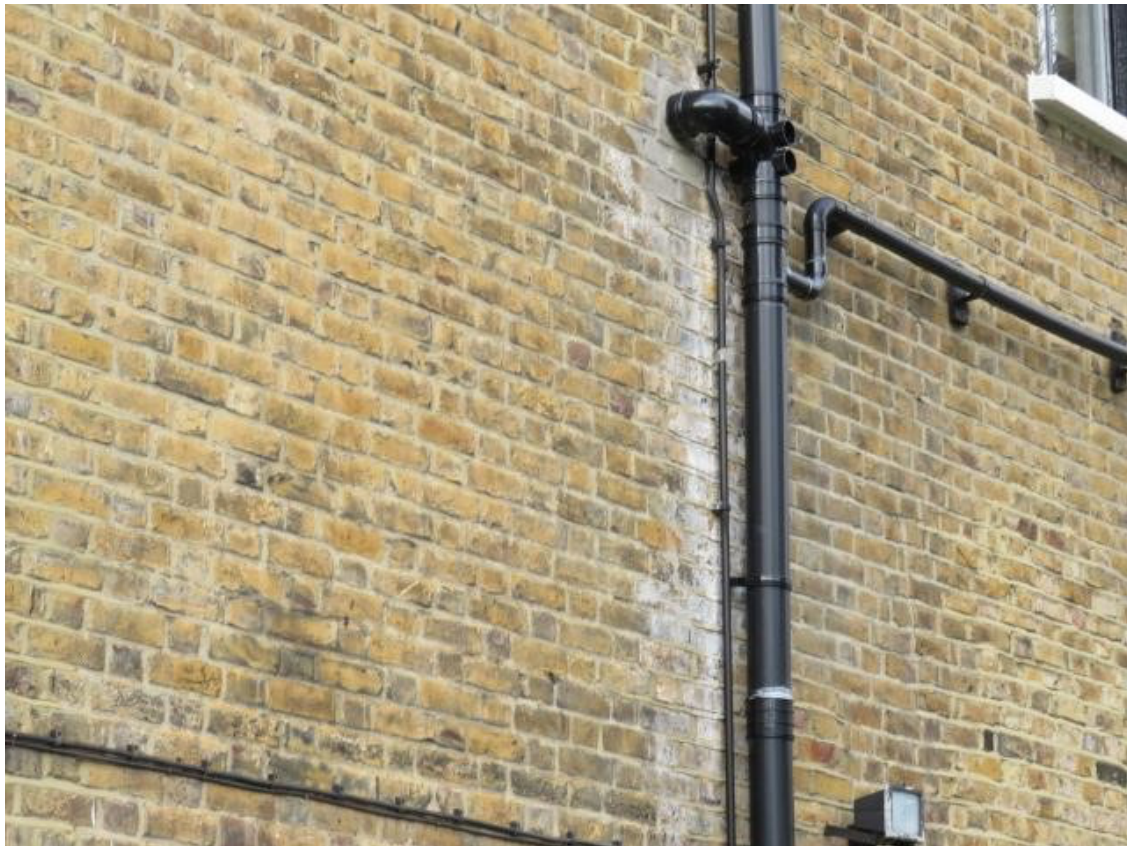
To the right hand side elevation at first floor level there is a vertical crack extending through a number of mortar joints approximately 10 brick courses, 1-2mm in thickness. We note some evidence of general repointing also on this elevation and the very close proximity of the tree and a tree that has been removed adjacent to the neighbouring property to the rear right hand corner. We also note that the brick bonding has not been staggered therefore the mortar joints run one above the other, which provides a weak point in the brickwork, so when movement occurs these areas are more likely to suffer movement related damage. In any event this will need stitch brick repairs and repointing to minimise the potential for further cracking and to maintain the structures weather proofing qualities. We consider this to be urgent.

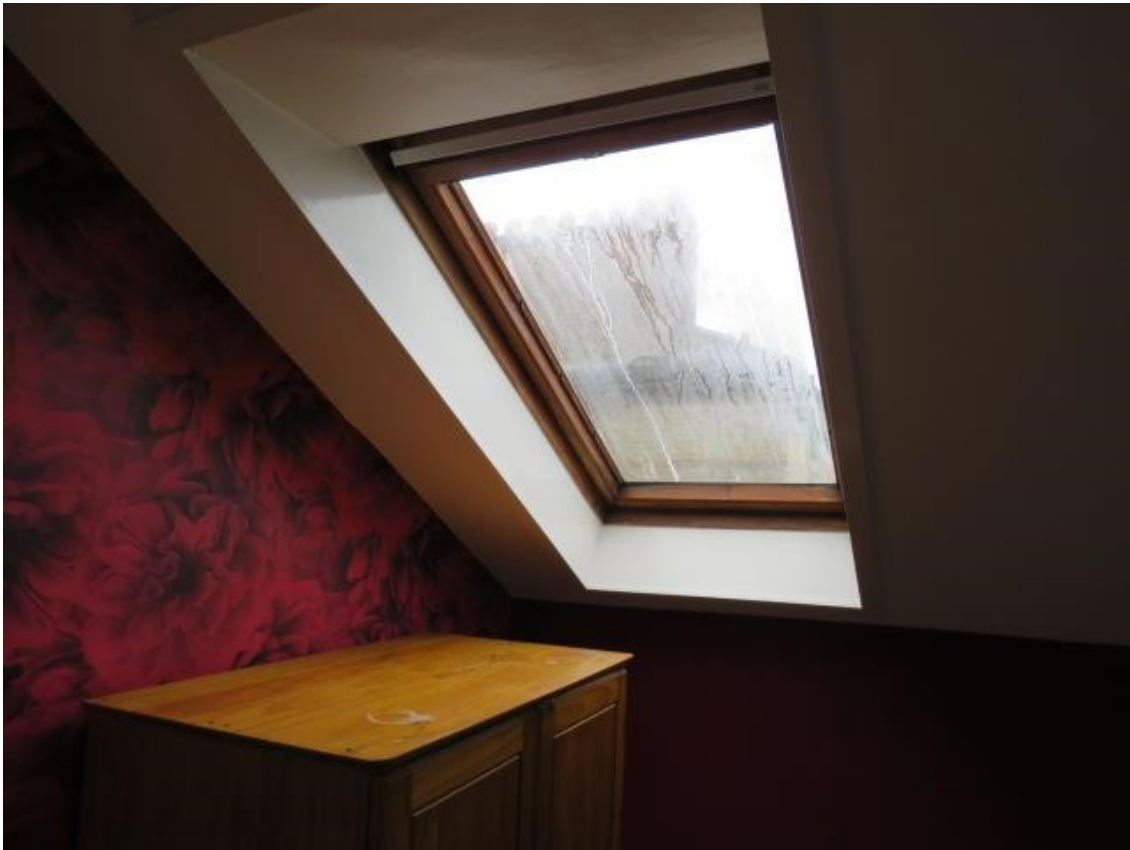
We would draw to your attention that the only secondary means of escape would be via the roof windows which are above 1 meter from the internal floor levels and difficult to access / potentially hazardous. Furthermore we note due to the exposed condition of the roof the roof lights when left open are exposed to window up lift and ideally restrictors should be installed which can be easily operated in the event of child safety / health and safety.
