BUILDING SURVEY REPORT

**EXAMPLE Pimlico,
London, SW1V 4HF**

AS INSPECTED BY MODRICS CHARTERED SURVEYORS

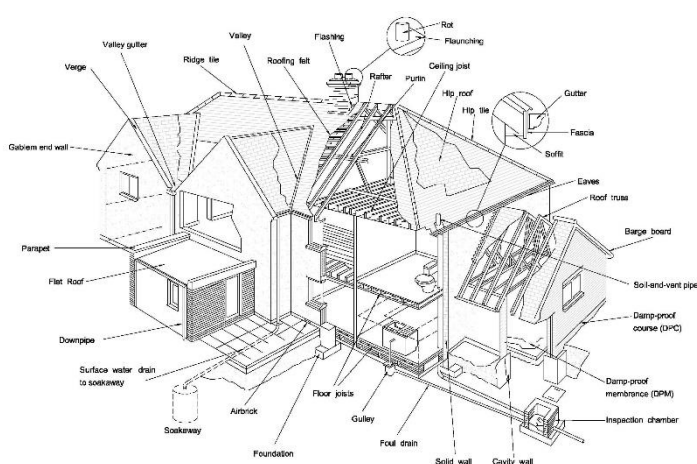
There are two brick built chimney stacks to the rear left hand side of the building with a large brick chimney stack lined with the position of the party wall. These chimneys appear to be shared with the neighbouring property.

Evidence of leaning and cracking is noted to the rear left hand side chimney stack, we would recommend that further access for inspection and repair is undertaken and any strengthening works / stabilisation works undertaken to minimise the potential for further crack damage and or leaning. We consider these to be urgent to minimise the potential for further damage.

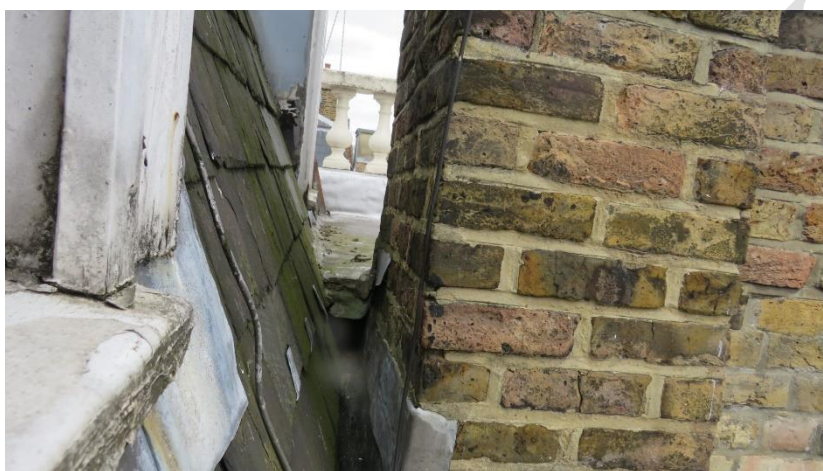
The main roof to the property appears to be formed in a mansard construction with sloping roof surfaces to the outer perimeters covered with a natural slate roof covering.

We note above the porch entrance there is a mineralised felt roof covering with large deposits of lichenous deposits on the surface. We note internally within the porch area there is high moisture meter readings for the full height and we are concerned that the roof may be leaking and requires further investigation and repair.

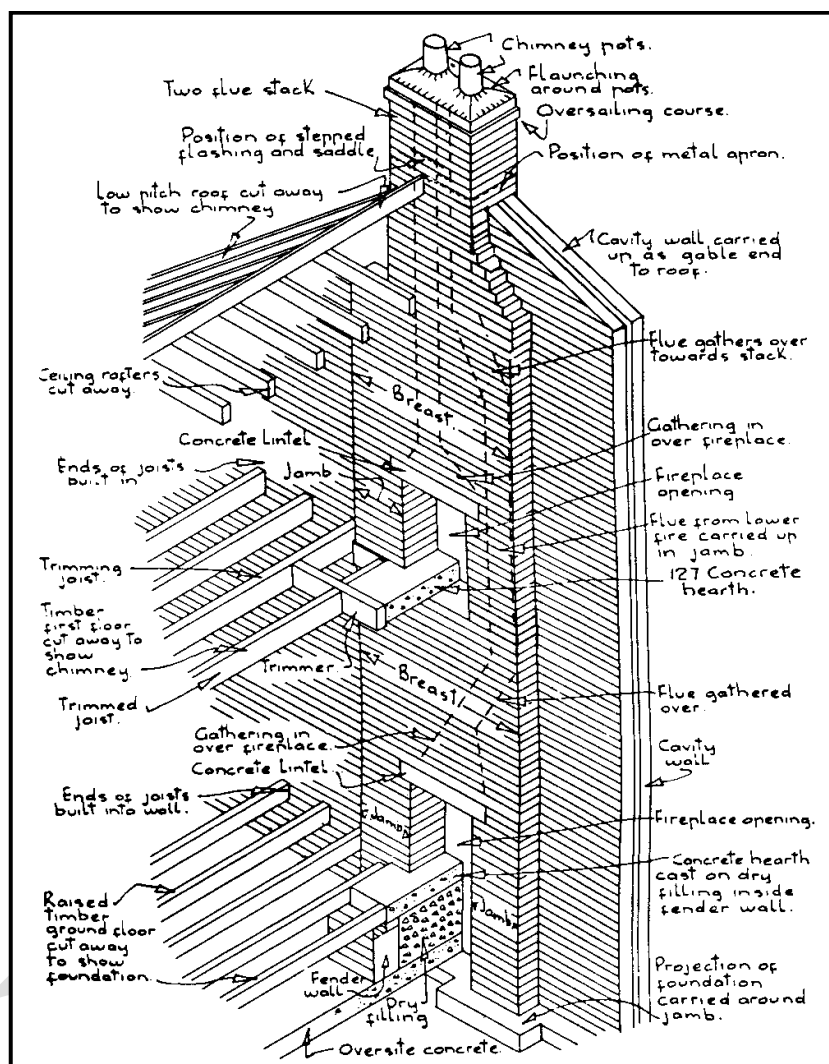
It is not possible to indicate the condition of the flues or the presence of any flue liners and no assumption has been given as to the practicality of using these chimneys in the future.

All blocked up flues should be provided with ventilation grills in order to minimise the risk of condensation from occurring within the flues.

Nevertheless, if these fireplaces were to come back into use they should be swept and checked by an engineer specialising in such flues.

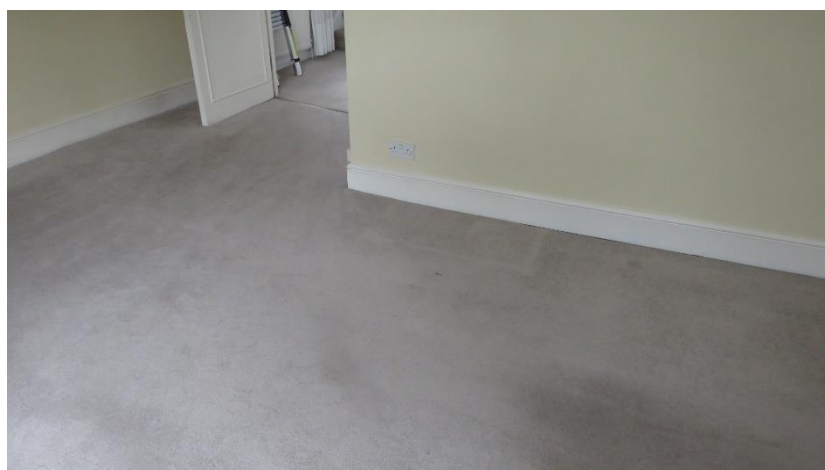
The floors were found to be reasonably firm and capable of bearing normal domestic loads. However, the main second and third floors are notably bowing and sagging. It should be noted that floors are one of the hardest areas to pass comment on due to the presence of furniture and fitted carpets. The risk must therefore be accepted that defects may exist beneath the carpets/floor coverings that are hidden from view.

We would refer to our comments under the internal wall section of the report, this may be due to historic movement and or previous alterations that have been undertaken to the flats and apartments below, for the increased loads that have been applied as part of the reconfiguration of the building into flats or material changes to flats below (ie removals of internal walls)

Floor structures are designed to the standard of the time, which are inferior to present day requirements in terms of the joists size and spacing. Therefore a degree of unevenness and springiness is expected to some of the floors. We would not recommend that you overload these floors and any alterations internally including the removal of walls should be carefully considered, having regard to the existing undulation to the floor. Relevelling these floors may be difficult and costly to achieve.
