BUILDING SURVEY REPORT

**Example Report
Ealing
W13**

AS INSPECTED BY MODRICS (SURVEYORS) LIMITED

On: 7th June 2021

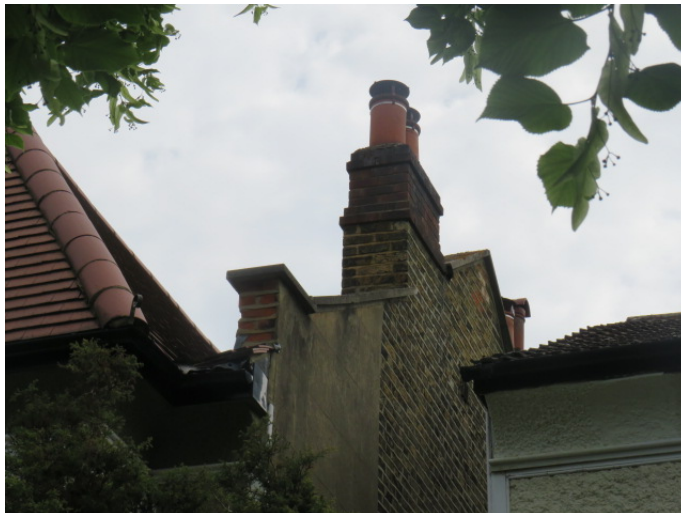
Slight leaning is evident to the chimney stacks, but otherwise no obvious signs of any significant cracking where possible to view. We note some minor hairline cracking to the pointing which will need repair.

order to prevent such dampness occurring. In this regard, some local deterioration and weathering is noted to the surface brickwork and pointing and this requires repair. When any pointing is carried out it is essential that the joints are raked out sufficiently, usually to a depth not less than 12mm so that the new pointing is given sufficient key. Failure to do this can result in the new pointing simply cracking and falling out over a relatively short timescale. The pointing itself should not be stronger than the bricks to which it is applied. Too high a cement content can allow shrinkage cracking.

(A number of spalled bricks have been patched with mortar. This is a temporary repair and proper cutting out and replacement, with new bricks, will be required in due course).

In order to slow down future deterioration of the brickwork, it is recommended that the brick surfaces be treated with a microporous transparent water-proofing solution. These solutions have the ability to prevent rain penetration while at the same time allowing trapped moisture to dry out. They are not long lasting and will require re-treatment in conjunction with future external redecoration programmes.

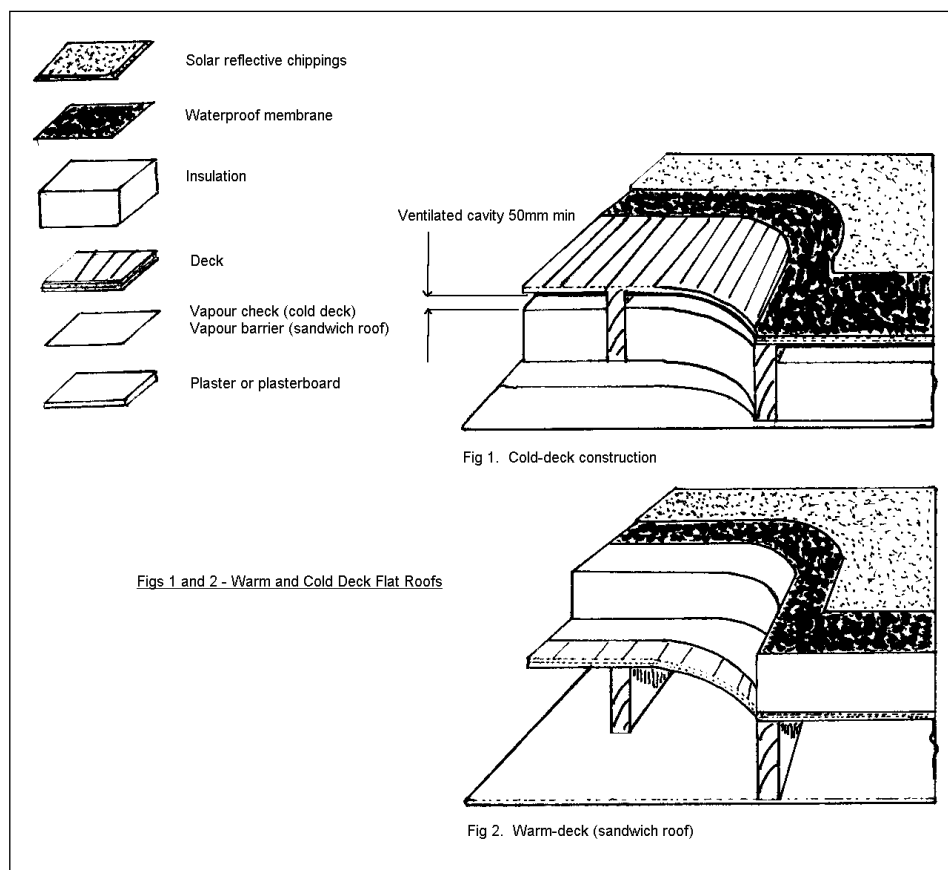
Regarding the flat roof coverings, it should be noted that compared with traditional coverings depending upon exposure, quality of felt and workmanship, flat roofs have a typical life span of 10 to 15 years. They are also prone to sudden failure and leakage. Continual maintenance and periodic re-covering will therefore be necessary. When the roofs are re-covered they should be insulated and ventilated in accordance with current Building Regulations.

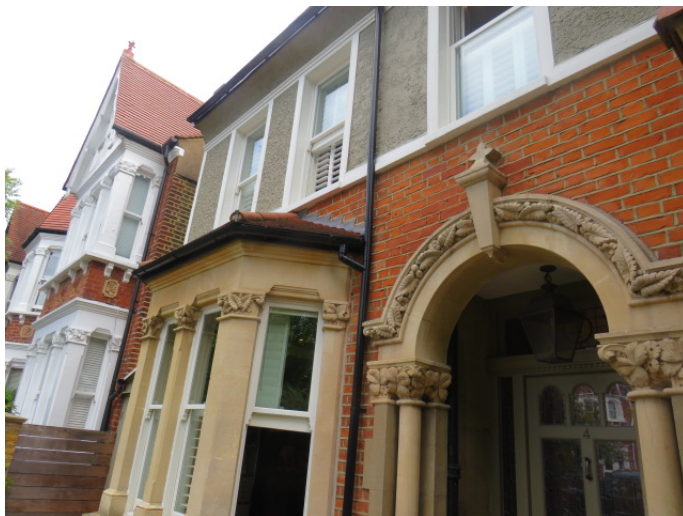
We note some general spalling and weathering to the stone/ashlar detailing around the front window bays and entrance area. This will need local repair/restoration to maintain its condition. There is some evidence of pointing repairs to the front bays to the left and right hand side returns where the bays meet the main building.

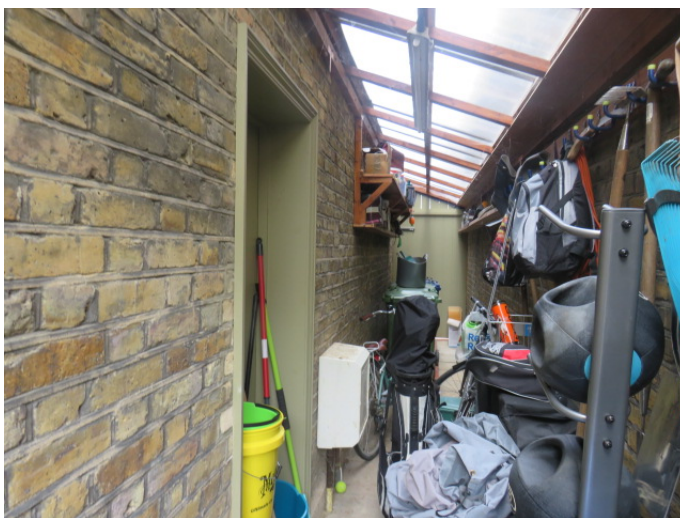
There are no outbuildings to the property. There is a small lightweight timber lean-to to the left hand side. Where visible this appears to be in serviceable condition. You should anticipate that some local repairs will be required to maintain its condition.

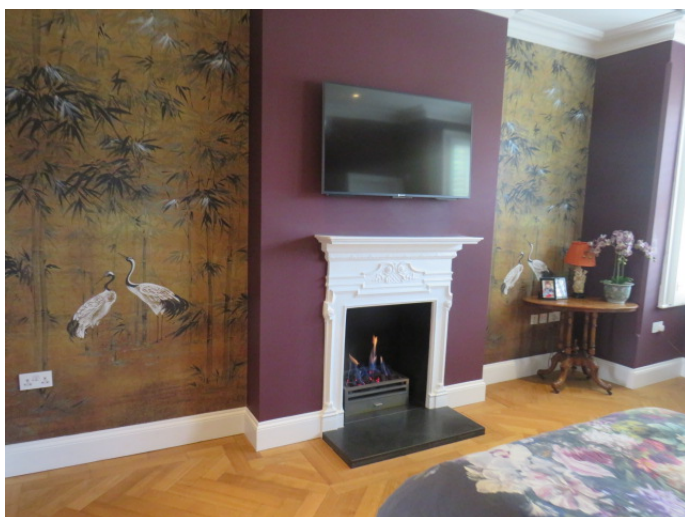
A gas fireplace has been installed within the ground and first floor rooms. These were turned on during the inspection and all appeared to be in working condition.

The gas fires should be tested before use by a Gas Safe registered engineer unless there is evidence of a recent gas safety check.

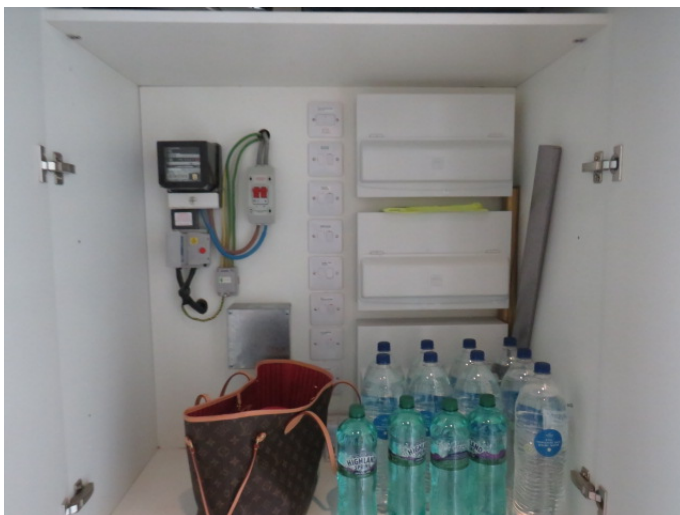
Electricity is connected to the mains supply; the mains consumer unit and 3No. meters are located in the cupboard accessed via the utility area.

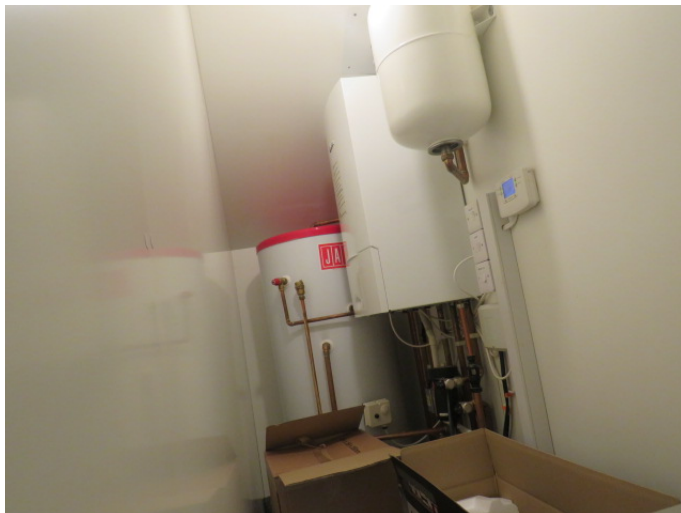
A wall mounted combination boiler is located within the cupboard accessed via Bedroom 5 with Megafluo cylinder adjoining.
