# HOME BUYERS REPORT

## **Example Report Ealing, London, W13**

AS INSPECTED BY MODRICS (SURVEYORS) LIMITED

On: 21st February 2021

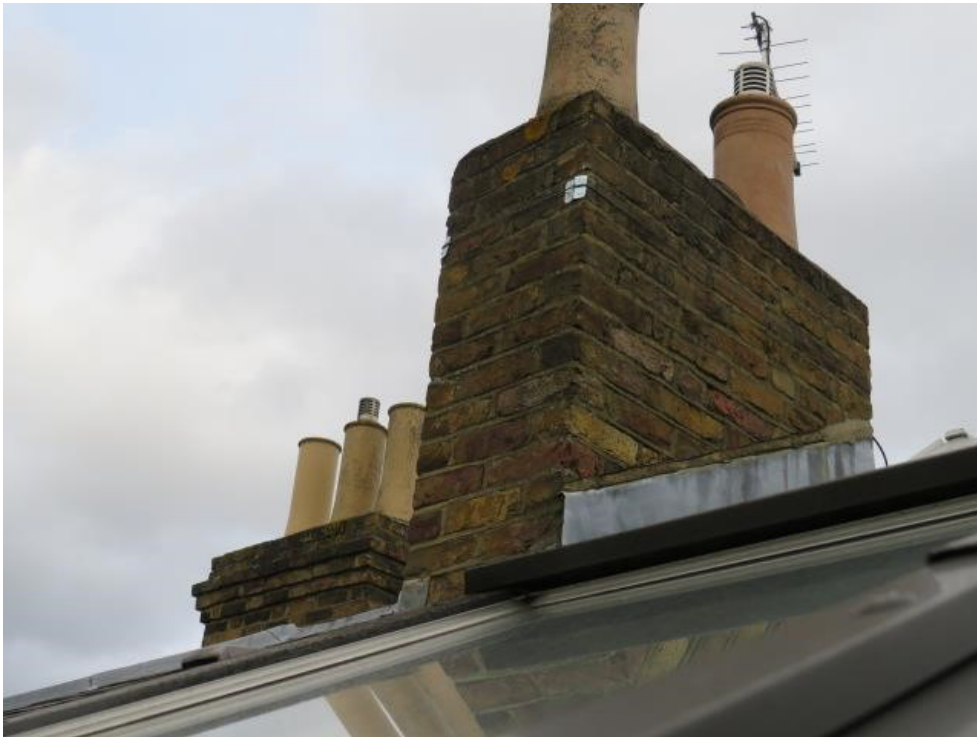
There are three brick built chimney stacks serving the subject property, these all appear to be shared with the individual flat.

We saw no visible signs of significant cracking or leaning where possible to view.

In this regard, some local deterioration and weathering is noted to the surface brickwork and pointing and this requires repair. When any pointing is carried out it is essential that the joints are raked out sufficiently, usually to a depth not less than 12mm so that the new pointing is given sufficient key. Failure to do this can result in the new pointing simply cracking and falling out over a relatively short timescale. The pointing itself should not be stronger than the bricks to which it is applied. Too high a cement content can allow shrinkage cracking.

We did note some intermittent cracking to the central left hand side chimney extending through approximately three / four brick courses, this will need repair.

In order to slow down future deterioration of the brickwork, it is recommended that the brick surfaces be treated with a microporous transparent water-proofing solution. These solutions have the ability to prevent rain penetration while at the same time allowing trapped moisture to dry out. They are not long lasting and will require retreatment in conjunction with future external redecoration programmes.

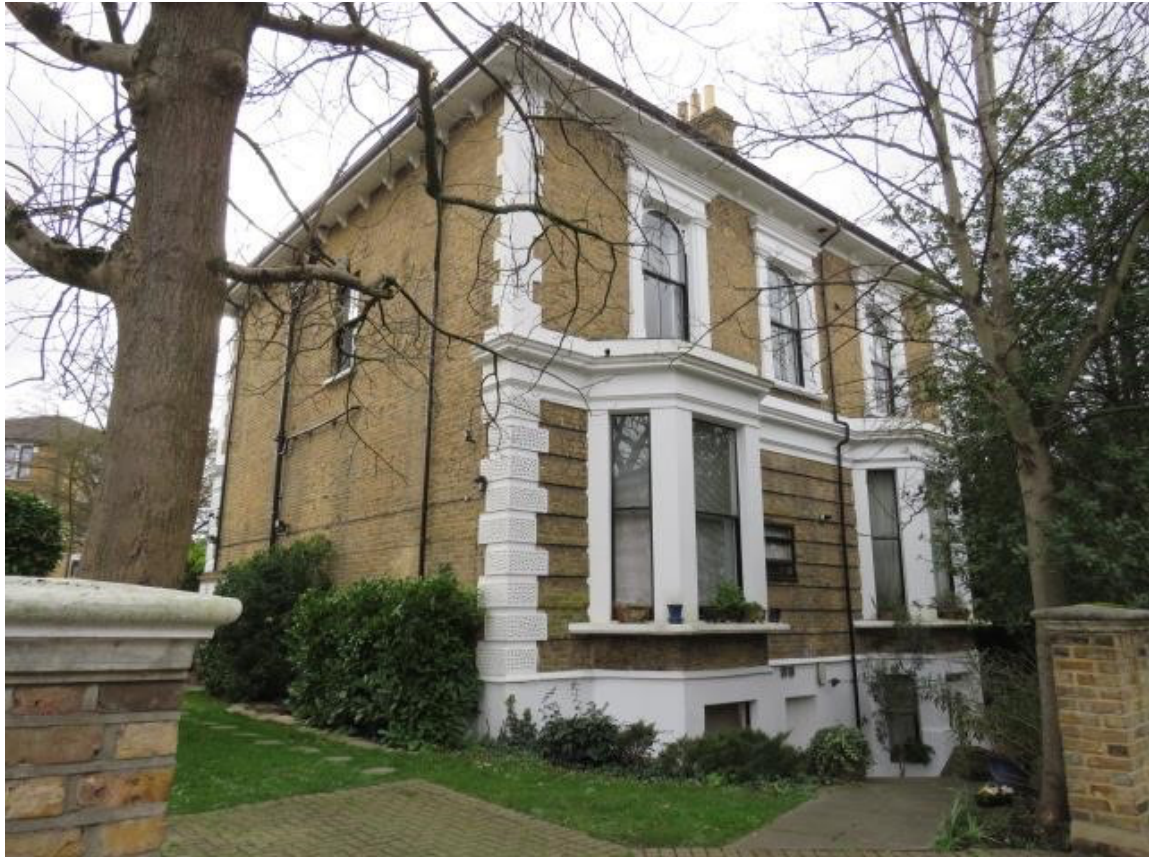
The main walls to the property are a solid brick construction with rendered painted detailing to the window and door openings around the central pillared entrance and to the corners / coins of the building.

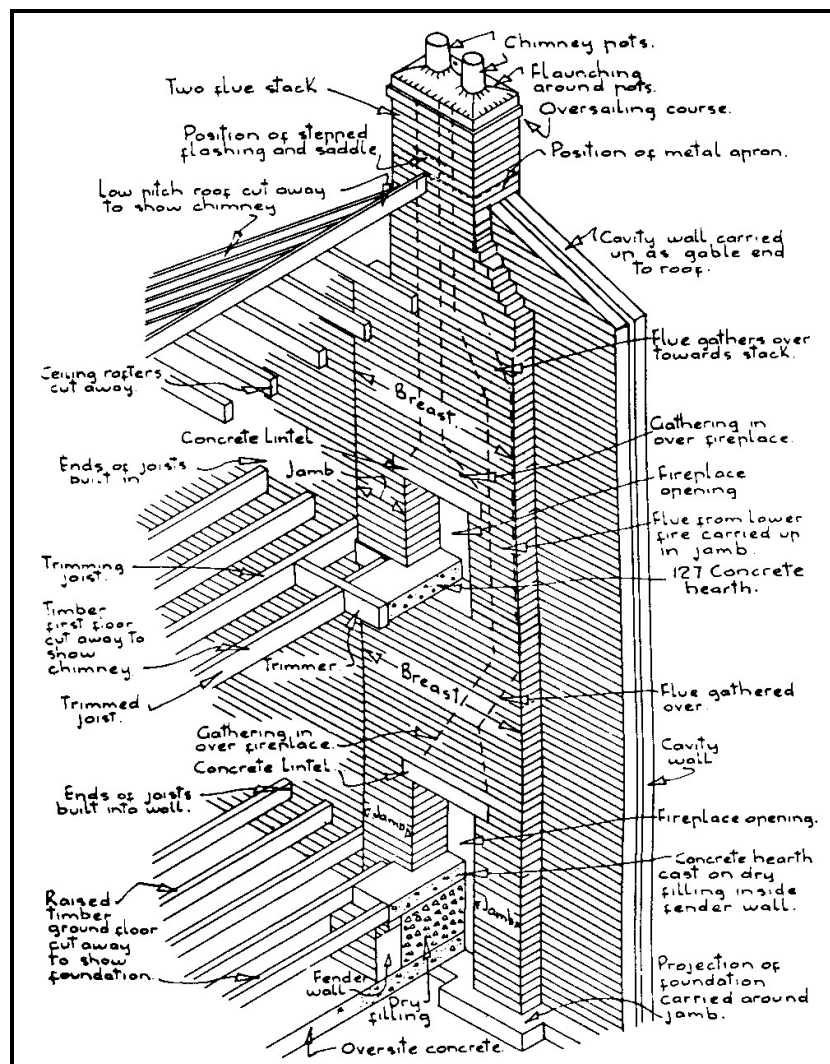
It is not possible to indicate the condition of the flues or the presence of any flue liners and no assumption has been given as to the practicality of using these chimneys in the future.

All blocked up flues should be provided with ventilation grills in order to minimise the risk of condensation from occurring within the flues.

Nevertheless, if these fireplaces were to come back into use they should be swept and checked by an engineer specialising in such flues.
